## *Pre-Purchase Marine Survey*

### *2024 Grady-White Canyon 336*

Acting at the request of Mr. Boat Buyer the attending surveyor did attend onboard the Grady-White on August 3rd, 2026, when a "Pre-Purchase Marine Survey" was conducted at the placeholder to evaluate the vessel to obtain a fair market value. The ship's papers were verified for this report. The Hull Identification Number (HIN) NTLWHXXA424 Was verified from the transom. A limited test run was performed. An out-of-water inspection of underwater machinery and the exterior of the hull's wetted surface area was performed. The survey was to ascertain the physical condition and value of the vessel for interested buyers. Moisture readings taken and referenced throughout the body of the report were taken with the Tramex Skipper Moisture Meter. A fluke VOM Meter was used to check the VDC & VAC power. This survey report represents the vessel's condition on the time, date, and place of the vessel during the day of the survey.

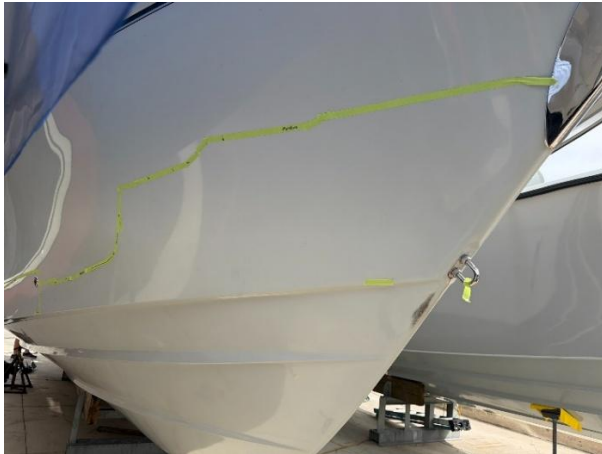
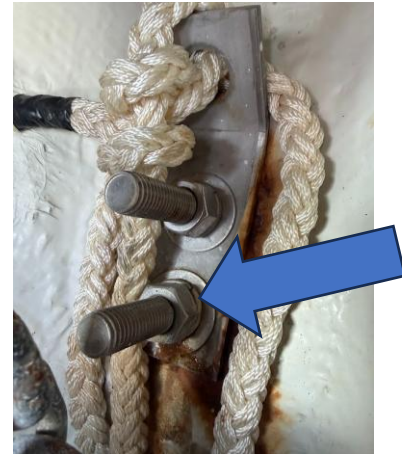
3. The forward D ring. There is indications that their seepage there.
4. Fisher panda fuel solenoid valve in the starboard aft build is heavily corroded recommend repairing or replacing this. Also add anti-corrosion on this to prevent further rust.

Active Water intrusion Bottom D-Ring

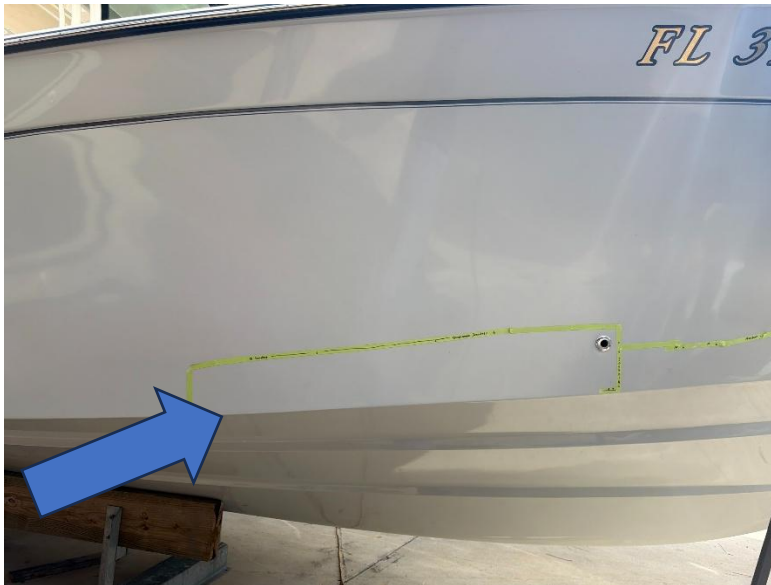
1. There is moisture up in the starboard Forward bow area up on the hull sides, See picture.
2. The starboard forward battery DEKA Group 27 is indicating a bad battery. Recommend charging this battery and monitoring this battery to make sure it's just a low charge.

5. There is an area on the starboard hull right above the chin, approximately 8 feet from the bow area all the way back starting at the stainless steel above where Line through hall fitting. This area goes for 57" Aft and is about 8 inches high. There is also an area of Forward BOW area that has high moisture see picture.

Strb Bow taped out to show high moisture and de-bonding in the aft section of the Above water line T/H fitting.

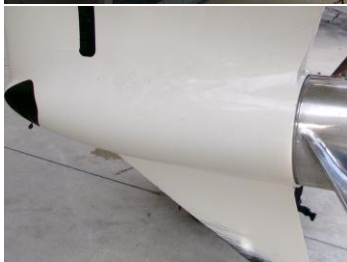
Bottom skeg scrapes

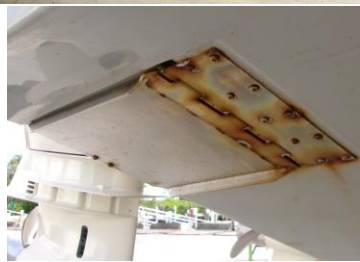
6. The port & strb S/S tabs are starting to corrode at the hinges and some of the support metal. Paint these with a primer and anti-fouling. Add zincs and monitor the screw heads.

S/S metal starting to rust both sides

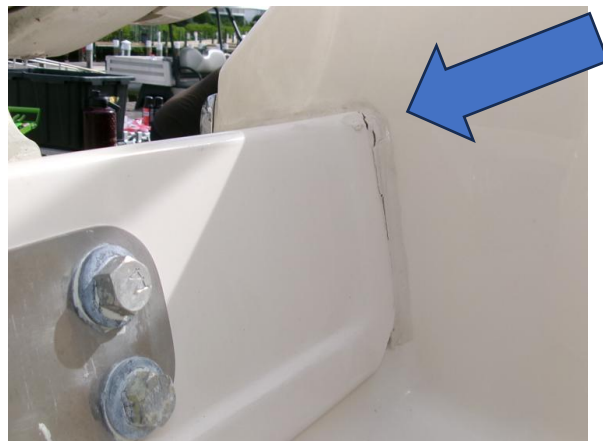
Re-caulk port & strb transom- normal

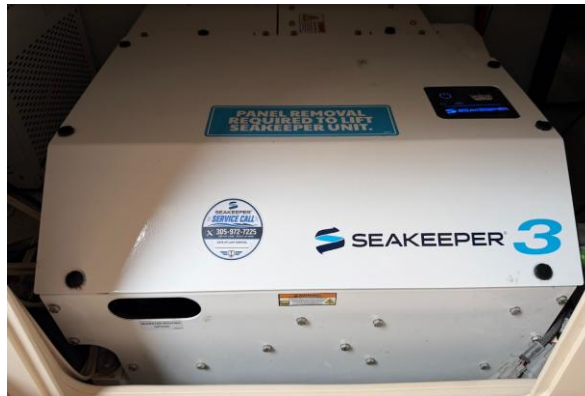
Clean SK 3

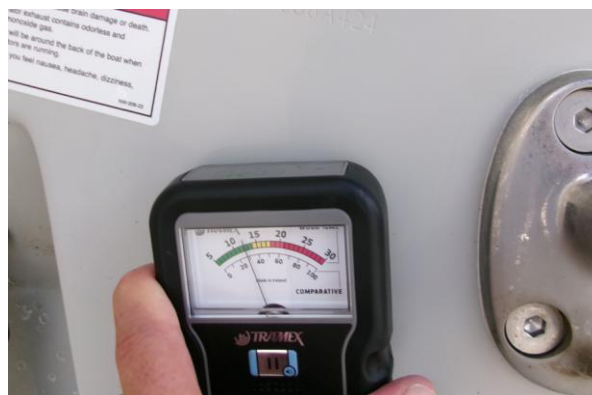
**Transom:** Percussion tested well. Checked with the moisture meter and found very low relative moisture in the inboard/outboard of the transom. The moisture meter used is a Skipper Tramex 5. Percussion testing produced solid soundings throughout this entire area.

Acceptable low Moisture Transom

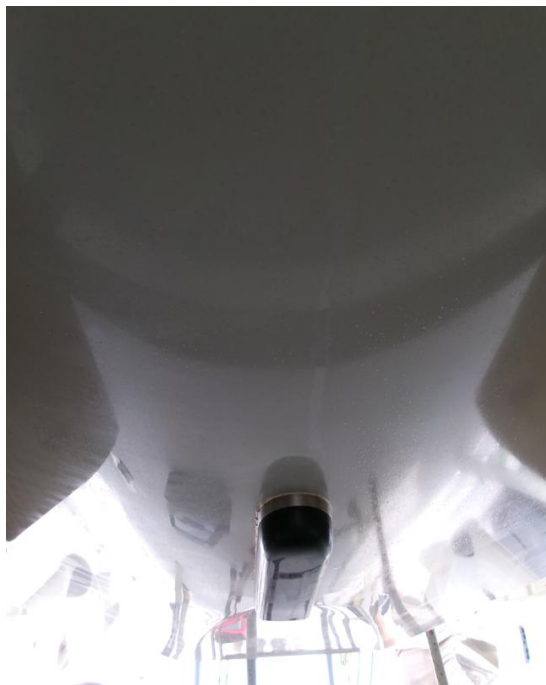
**Bottom aft hull W/ transducer- Clean**

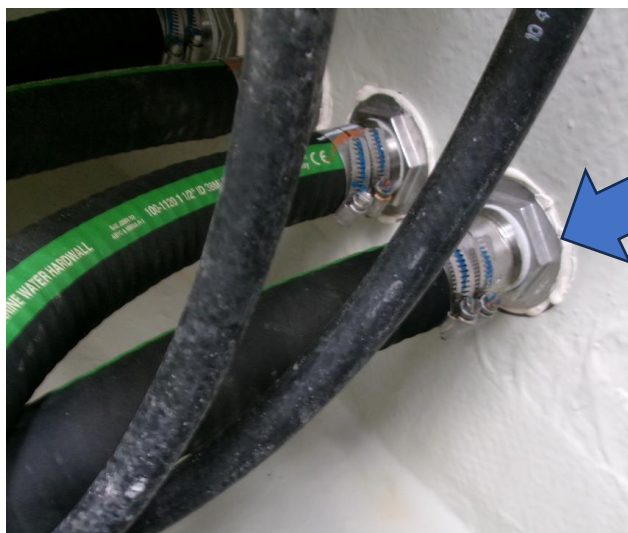
**Scuppers:** Inspected the hoses and clamps- Good Condition, proved and tested.

**Port Side Scupper Hoses & FG Lay-up – Good Condition**
