## *Pre-Purchase Marine Survey*

### *2024 Grady-White Canyon 336*

Acting at the request of Mr. Boat Buyer the attending surveyor did attend onboard the Grady-White on August 3rd, 2026, when a "Pre-Purchase Marine Survey" was conducted at the placeholder to evaluate the vessel to obtain a fair market value. The ship's papers were verified for this report. The Hull Identification Number (HIN) NTLWHXXA424 Was verified from the transom. A limited test run was performed. An out-of-water inspection of underwater machinery and the exterior of the hull's wetted surface area was performed. The survey was to ascertain the physical condition and value of the vessel for interested buyers. Moisture readings taken and referenced throughout the body of the report were taken with the Tramex Skipper Moisture Meter. A fluke VOM Meter was used to check the VDC & VAC power. This survey report represents the vessel's condition on the time, date, and place of the vessel during the day of the survey.

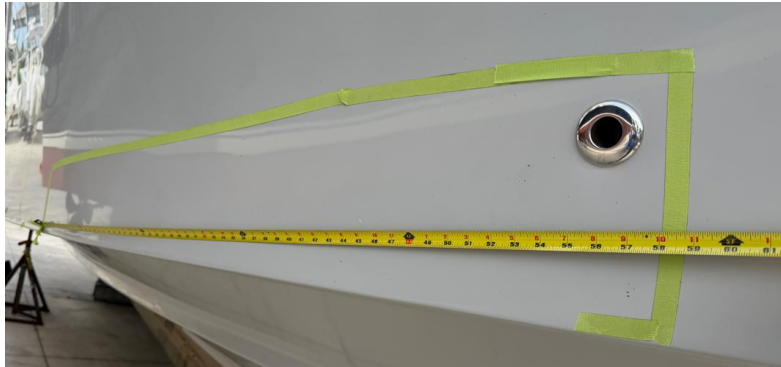
**Hull to Deck Joint:** Shoe box type, secured with stainless steel fasteners. Inspection of this was limited to the anchor locker. No defects found on this joint.

**Hull Sightings:** Fair to the eye.

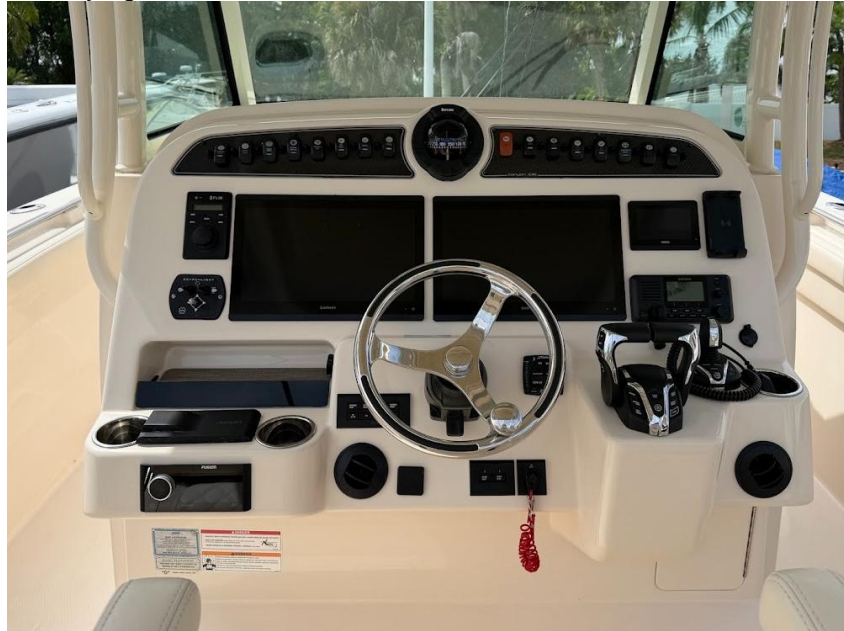
**Findings:** Navigation lights operated at the time of inspection. Please check navigation lights before every underway operation.

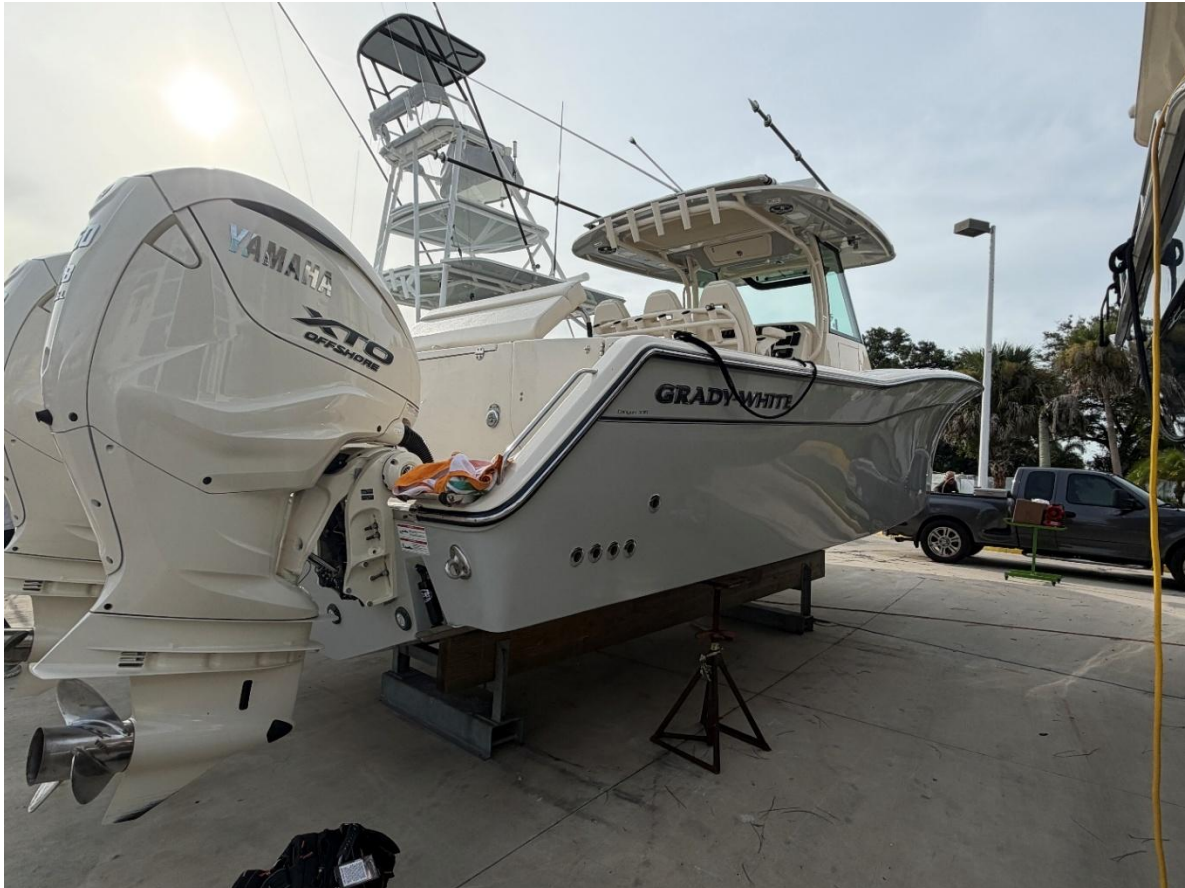
Re-caulk port & strb transom- normal
